ARMORED MEDICAL RESEARCH LABORATORY

Final Report

PROJECT NO. 41 - PHYSIOLOGICAL AND OPERATIONAL CHARACTERISTICS
OF TANK T25E1.

8 November 1944

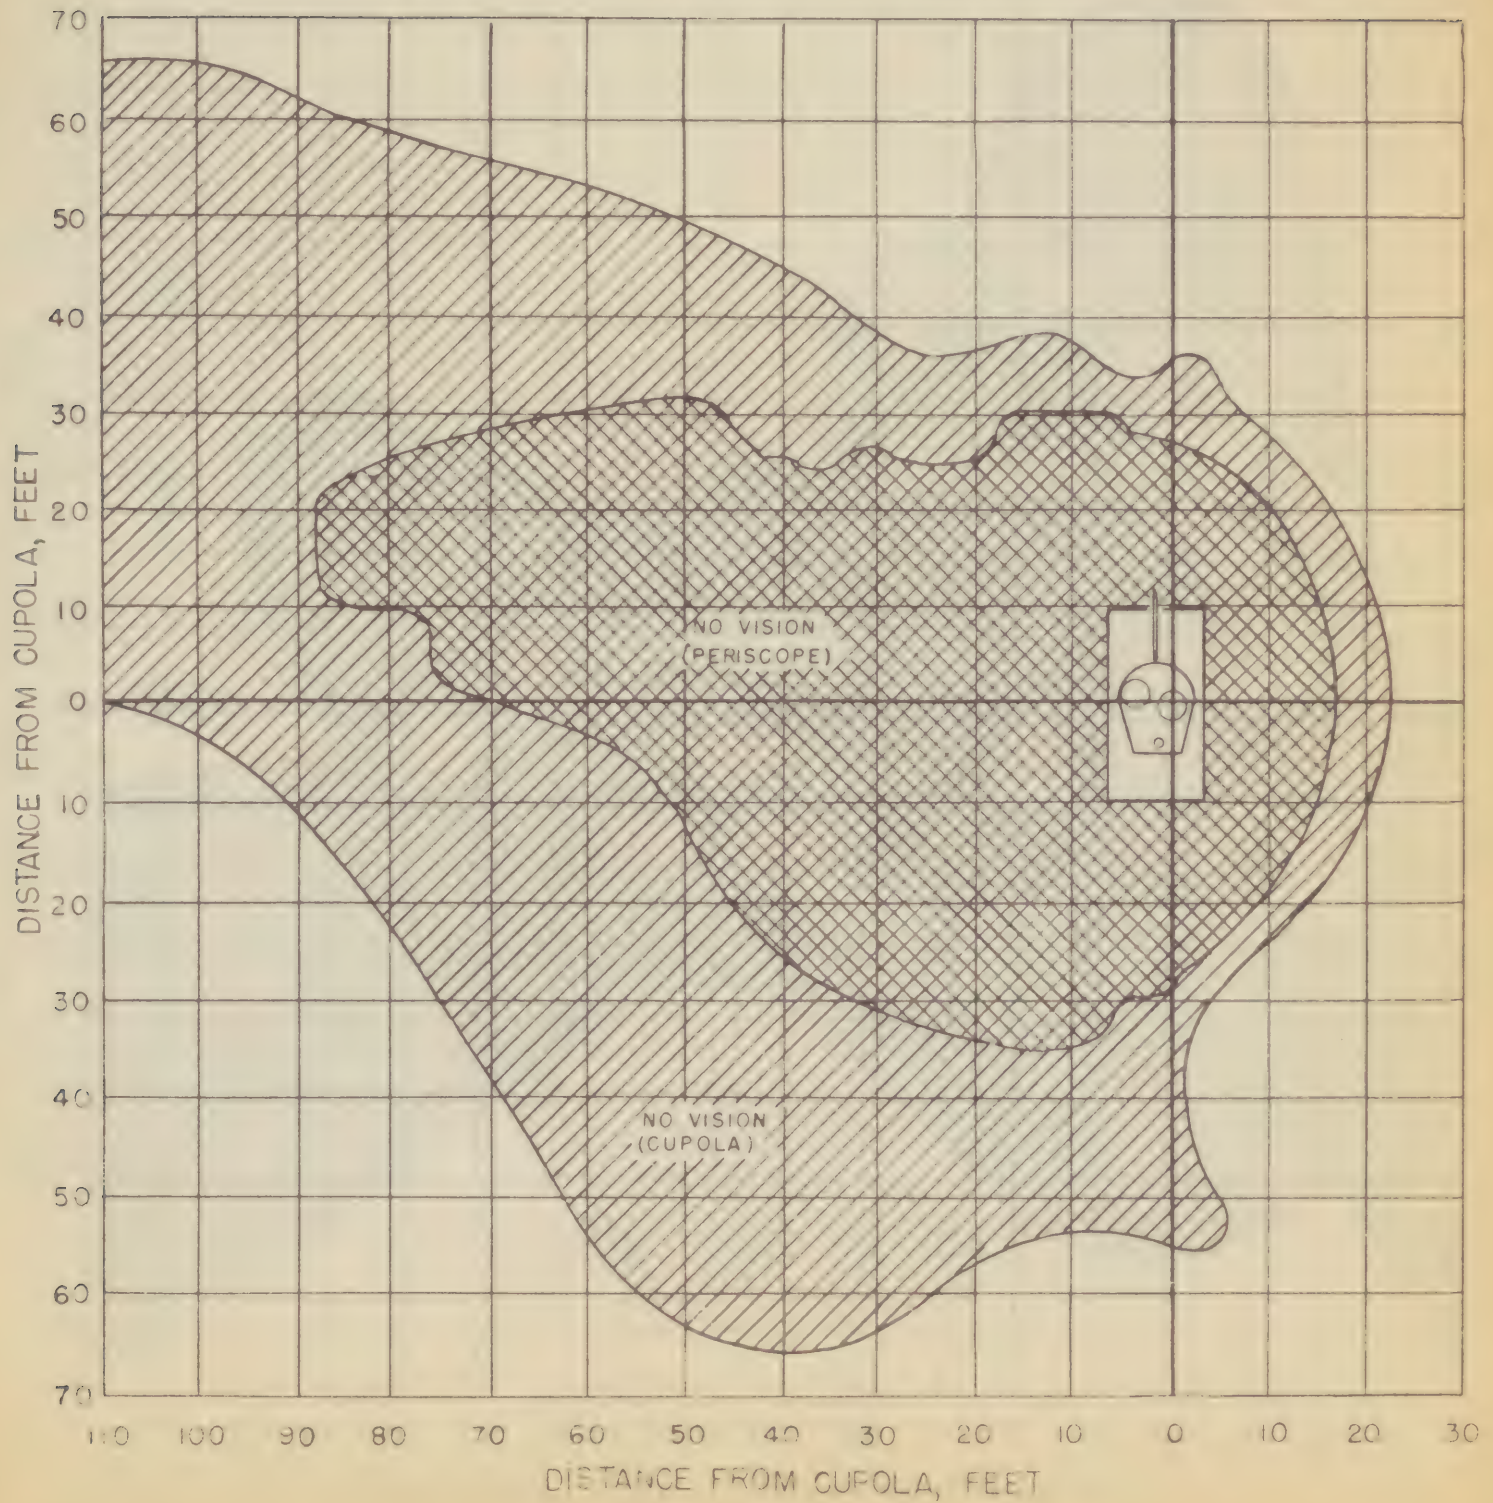
FIG.1
LIMITS OF COMMANDERS GROUND VISION
THROUGH PERISCOPE AND VISION CUPOLA
T 25 EI TANK

a. Commander: The limits of ground vision provided through the periscope (by rotation) and through the vision cupola are shown in Fig. 1. The limitation in vision to the left and to the rear are clearly illustrated. The vision to the right flank is only fair. The vision blocks were found to be defective in that there were many internal bubbles which appeared to increase with age. The surface of one block was destroyed over a large area by grinding. No padding for head protection is provided. The ball race was found to jam quickly with dirt and grit, especially when operating with hatch open. This deficiency which has been previously pointed out, greatly reduces the value of the rotating periscope or periscopic binoculars.

a. Immediate consideration be given to the development of an improved vision cupola with less limited ground vision. In new design provide for hatch inside rotor as previously recommended, rather than with rotor in the hatch.

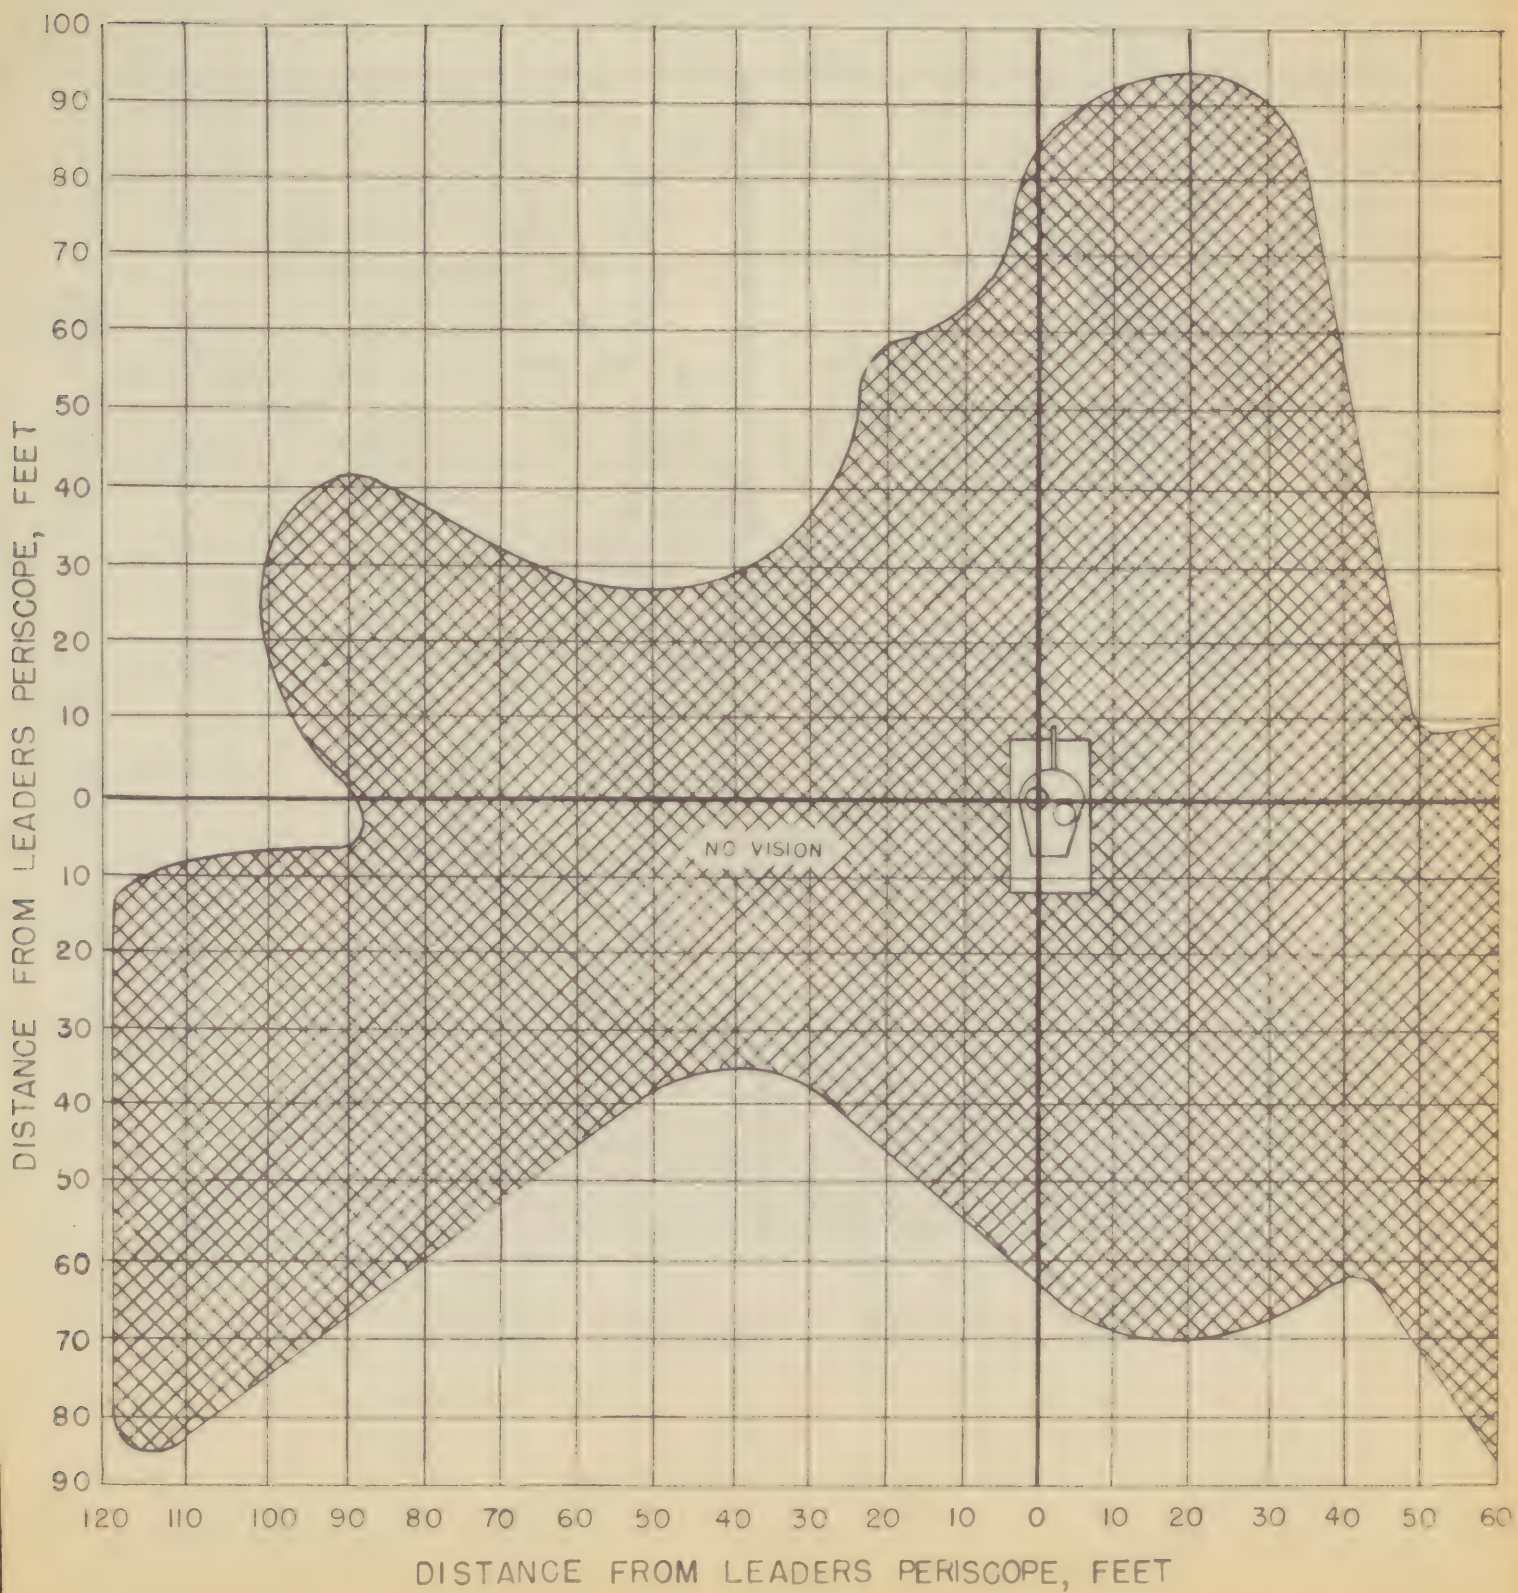
FIG. 2
LIMITS OF LEADERS GROUND VISION
T 25 EI TANK

b. Loader: The limits of ground vision provided through the loader's periscope are shown in Fig. 2. The closeness of vision to the tank is not greatly improved over that of the commander. Since the loader is the only crew member who is in a position to obtain close vision on the left, improvement is required. This can be obtained by the installation of rhombic vision units in the side armor.

b. Provide rhombic vision units in turret wall for loader, in order to secure near ground vision.

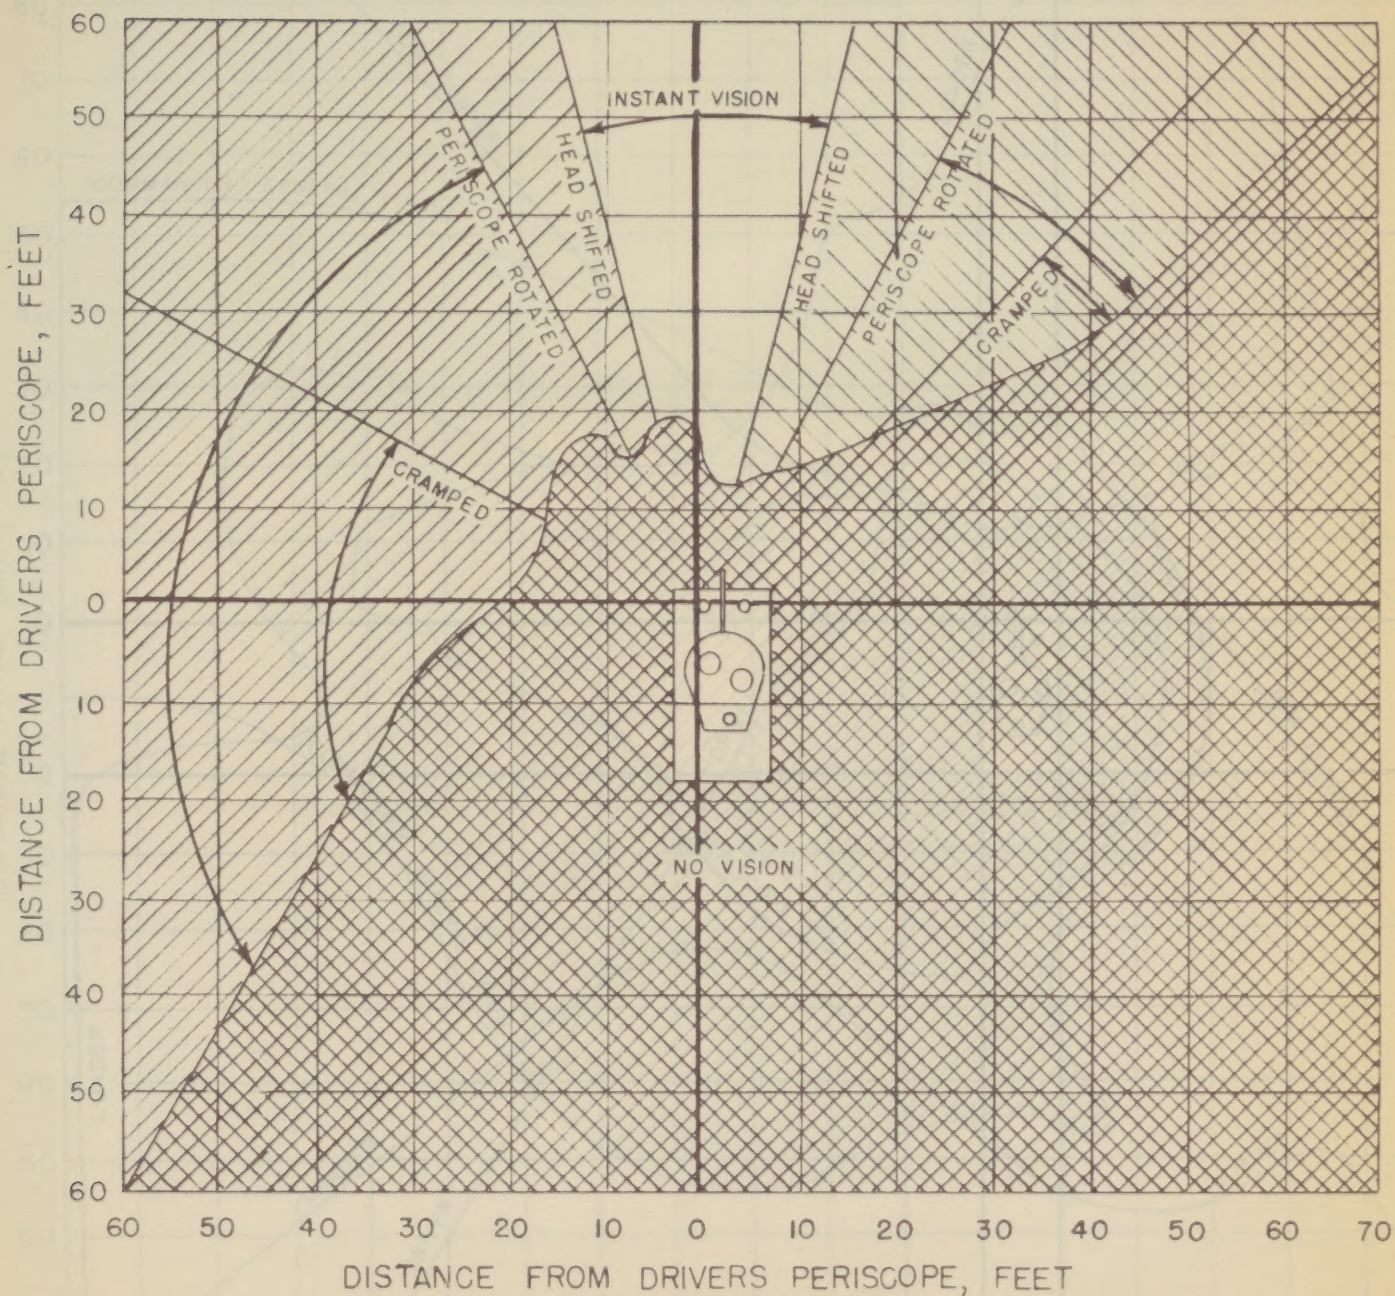
FIG. 3
LIMITS OF DRIVERS GROUND VISION
T25 EI TANK

c. Driver: Limits of ground vision are shown in Fig. 3. The M6 periscope is unsuitable for driver vision owing to its restricted field of view. Furthermore, the driver cannot conveniently make the continual re-adjustments necessary to gain even partial knowledge of the ground to be traversed. The secondary periscope is too inaccessible to supplement vision through the main instrument. The rib which projects down around the inside of the hatch and the projection of the turret ring bearing interfere with the driver's head movement and prevents his effective use of the secondary periscope.

c. Provide driver with wide field vision units (blocks or rhombs) possibly supplemented by periscope for cross-tank vision.

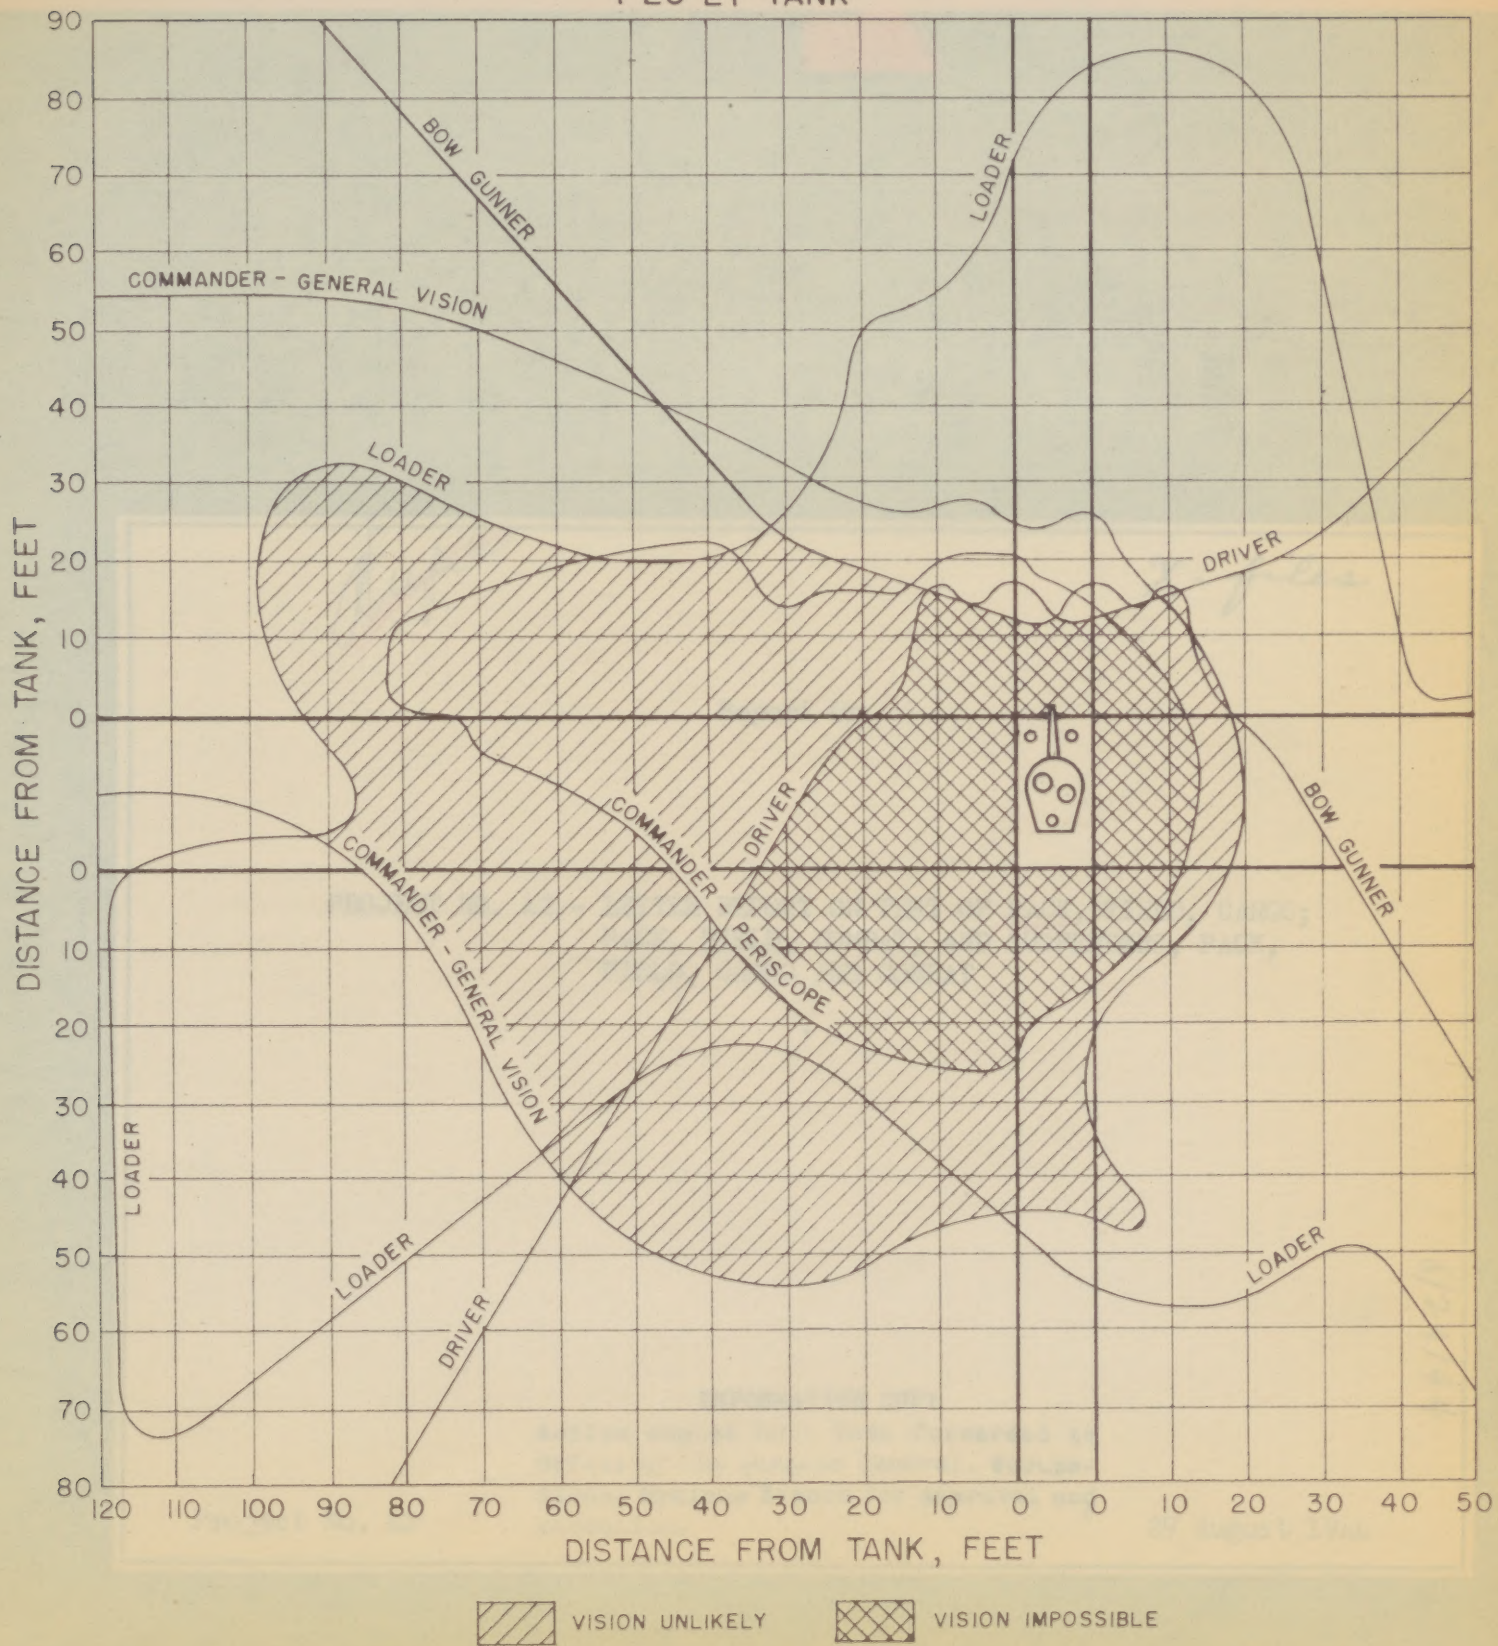
FIG 4

d. Combined Vision: Immediate and close-in ground vision surrounding a tank becomes increasingly important when operating in terrain which provides close infantry cover. The overall limits of ground vision provided in the T34, shown in Fig. 4, fail to provide this necessary close-in vision. The vision cupola is especially lacking in downward vision and the raised ring of the loader's hatch obstructs cross-tank vision from the cupola. The large flat turret top sets a limit to downward vision from any vision device placed low in the rood.
